# AUGUST 10, 2023 FLOOD INVESTIGATION REPORT

DRAFT SUMMARY REPORT WARD 16

Asset Management (Water Resources)

December 14, 2023

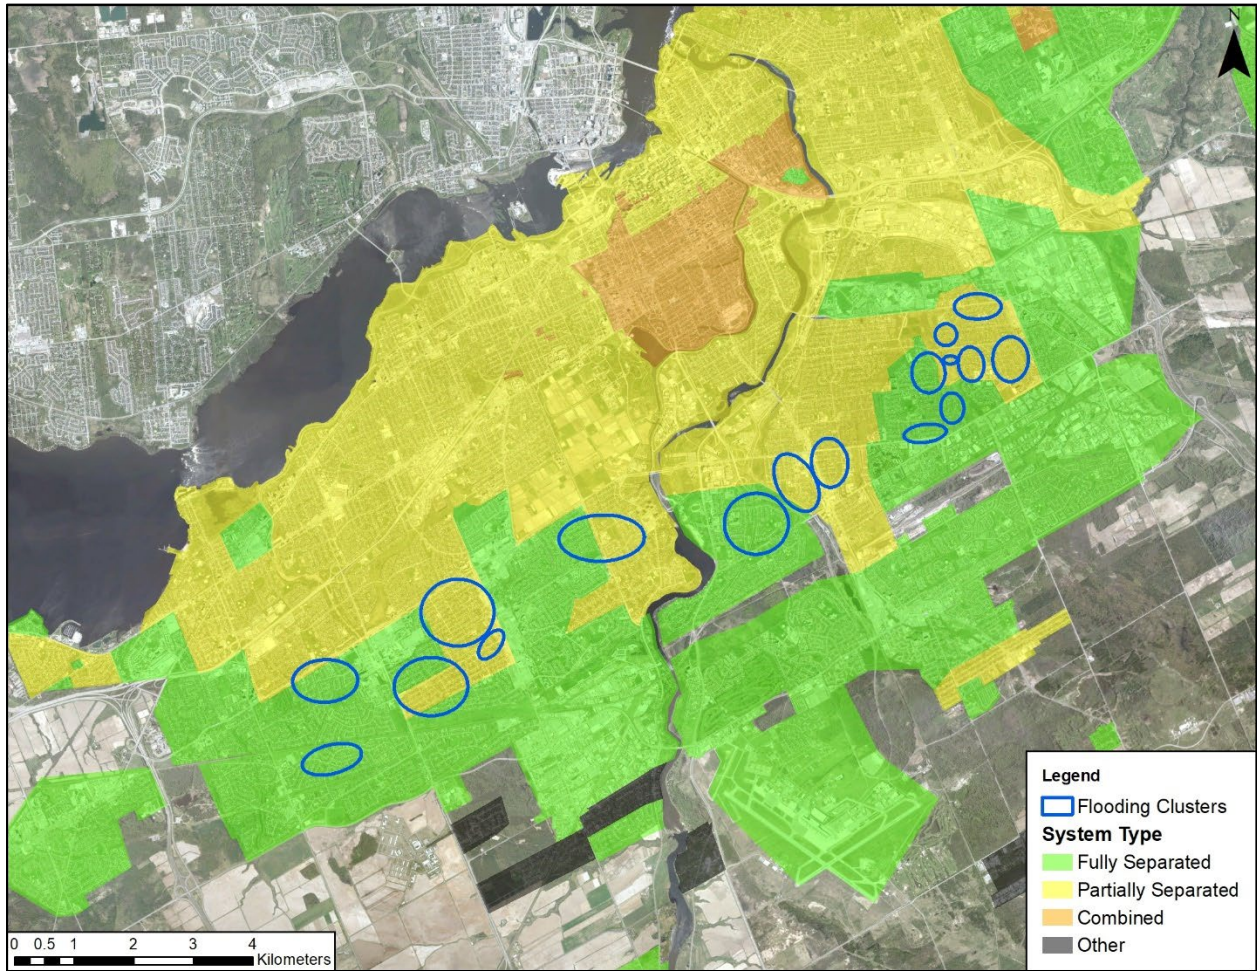
**Figure 1 – System Type and Flooding Clusters**

In 1961 the City of Ottawa passed a bylaw that required that all new sewer systems be fully separated. In other words, a sanitary sewer system would be designed for domestic flow only and a deeper storm system would capture surface runoff and foundation drain flow. The City even proceeded to separate sewers in some of the combined areas, however due to outlet restrictions, the storm sewers were shallow and foundation drains remained connected to the sanitary sewers. Also, in many areas where ditch drainage existed, the City constructed storm sewers, but again due to various drainage conditions or limitations the sewers were shallow and foundation drains remained connected to the sanitary system. ***All areas that have foundation drains connected to the sanitary sewers are referred to as partially separated. Figure 1.0 below, shows an approximate outline of the partially separated systems (in yellow) and fully separated systems (in red) in the southern portion of the City core, which was most affected by the storm.***

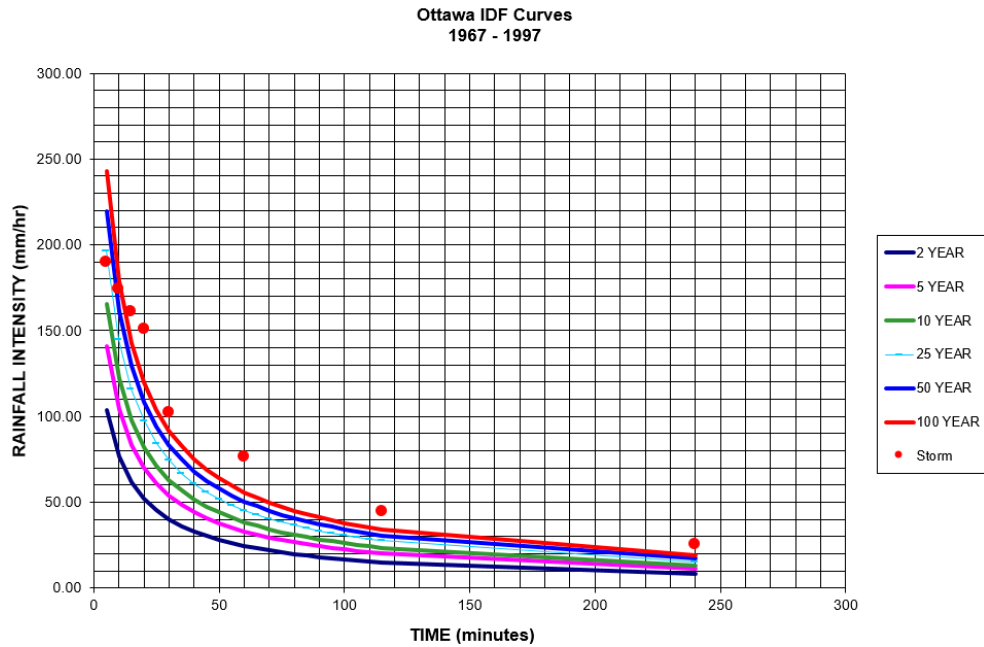
**Figure 2 - Colonnade Road Rain Gauge**

The average rainfall in the partially separated area was 60 mm with a peak recorded volume of 107 mm. The peak intensity of the event reached 190 mm/hr at the Colonnade rain gauge. Although the event did not reach the peak 100 year peak intensity of 243 mm/hr, it lasted longer than a typical storm, therefore the sustained intensity created an effect similar to a 100 year storm. Figures 2 and 3 below show the Intensity Duration Frequency (IDF) curves for the event at the Colonnade and Mooney’s Bay rain gauges. It is apparent from the graphs that as the storm progressed, the curve moved into the 100 year range due to the sustained intensity over a long period of time.

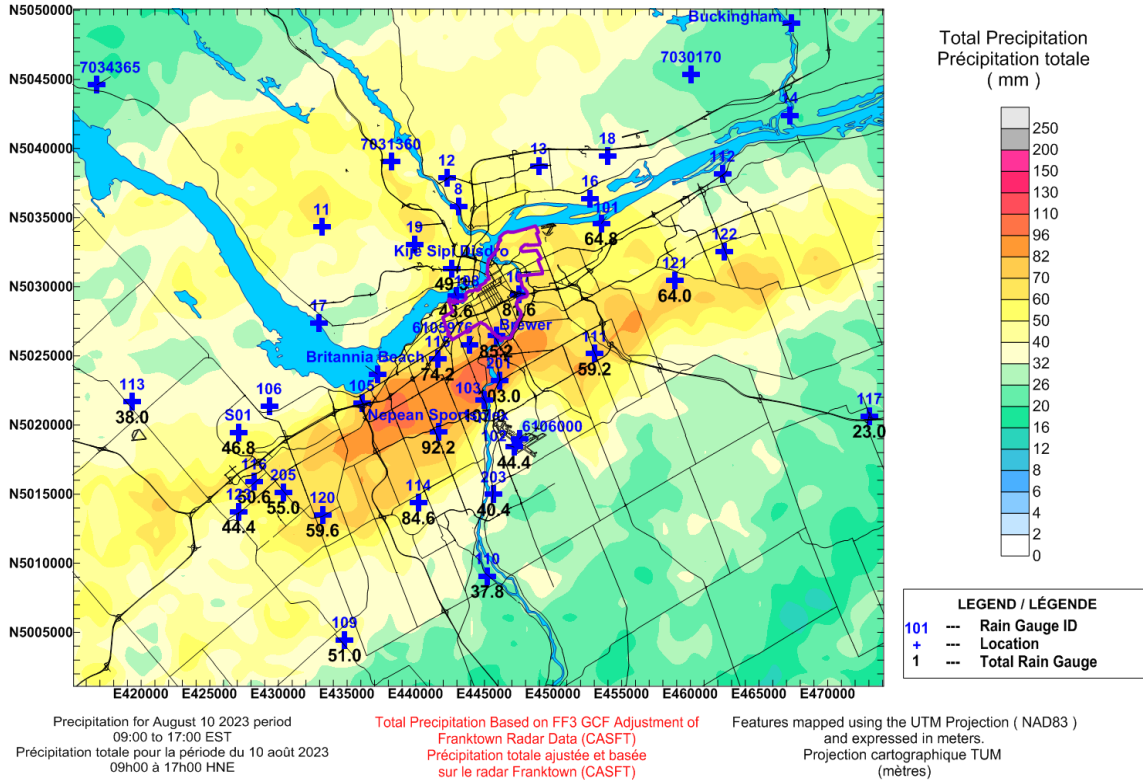
**Figure 4 – Path of Storm Peak**

Although the storm of August 10<sup>th</sup> affected the entire city, the peak of the storm followed a band near the south end of the City core. The rain gauges along that band showed the greatest rainfall

volume and intensity. Figure 4.0 shows the approximate path where the highest rainfall was experienced.

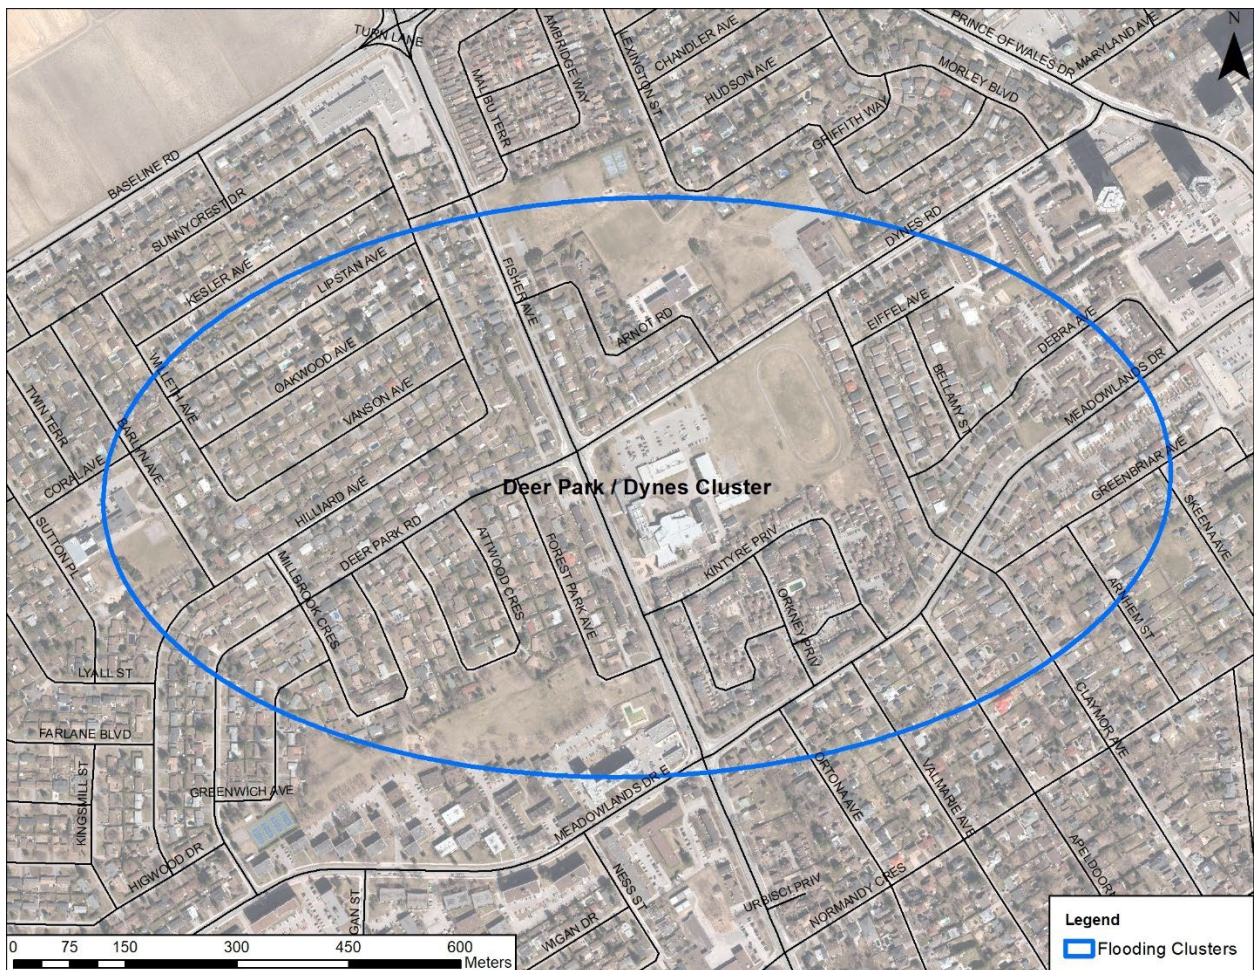
Figure 5 – Deer Park / Dynes Cluster, August 10 Flooding

- **Location and System Characteristics:** Eighteen homes (19) reported flooding in this cluster, 13 in the Deer Park area in Ward 9, and 6 in the Dynes Road area in Ward 16. The Deer Park area is fully separated meaning that weeping tiles are connected to the

storm sewer system and more prone to flooding from storm sewer surcharging. The Dynes Road area is partially separated and thus more prone to basement flooding from sanitary sewer surcharge. There was also a report of deep roadway flooding on Arnot Road by St. Augustine School and excessive roadway flow on Meadowlands from Fisher to Orton.

- **Type of Flooding:** First response data does not provide any indication as to how the properties flooded.
- **Previous Flooding:** The Deer Park and Dynes area have experienced historical flooding since 1979 with over 50 reports of basement flooding. Approximately half the flooding occurred in 2004 when Hurricane Frances caused sanitary sewer systems throughout the

- **Probable Cause of Flooding:** It is difficult to determine if flooding was due to a surcharged sanitary system or surcharged storm system without confirmation of the water entry point to the homes. Computer simulations show that the Dynes Road area would have been more at risk from sanitary sewer surcharge. We are still soliciting and receiving flood questionnaire and will have a better understanding of the cause of flooding in the near future.

- **Next Steps:** Communication with residents will be required to explain the benefits of installing backwater valves and how to protect homes from flooding. The local storm and sanitary sewer system will also be reviewed using the computer models built for the previous sewer upgrade projects to see if any additional improvements can be done to reduce the surcharge level during critical events. The overland flow system on Arnot will also be looked at to see if there are way of minimizing the accumulation of water at the low point. It must be noted however, that grading limitations may greatly hinder such an undertaking and that affected homeowners may need to take additional measures to protect their properties if the ponding poses a risk to their building.

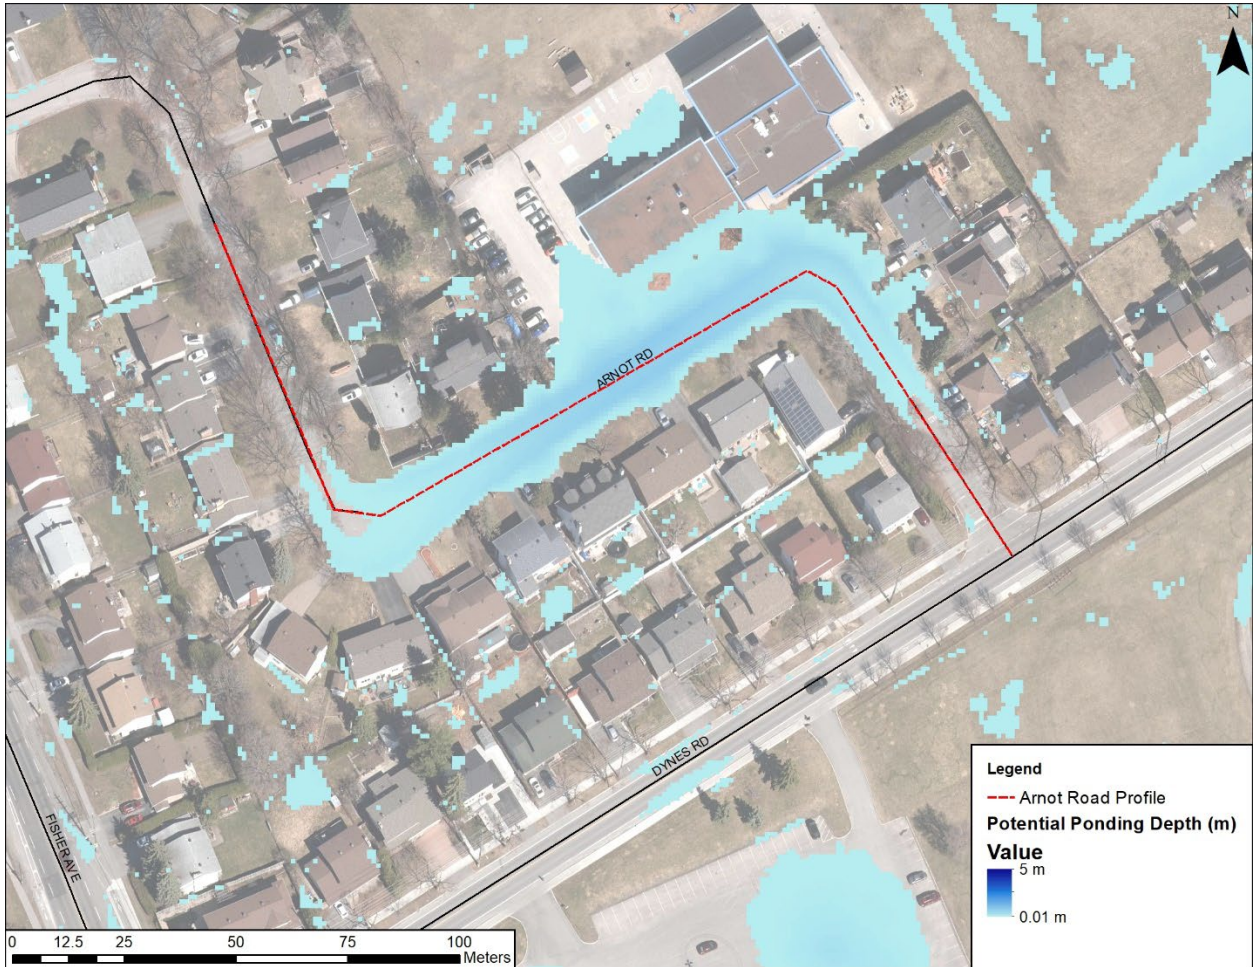
**Figure 6.1 –Ponding Depth on Arnot Road before spilling to Dynes Road**

The roadway flooding on Arnot Road is due to a low point in the road. Water must pond to a depth of approximately 0.8 m before spilling to Dynes Road. This is only problematic during extreme rainfall events. There were also reports of deep water on Meadowlands from Fisher to Ortona, however there are no ponding low points in that area and the depth of flow is simply the depth of the overland drainage system during critical events.

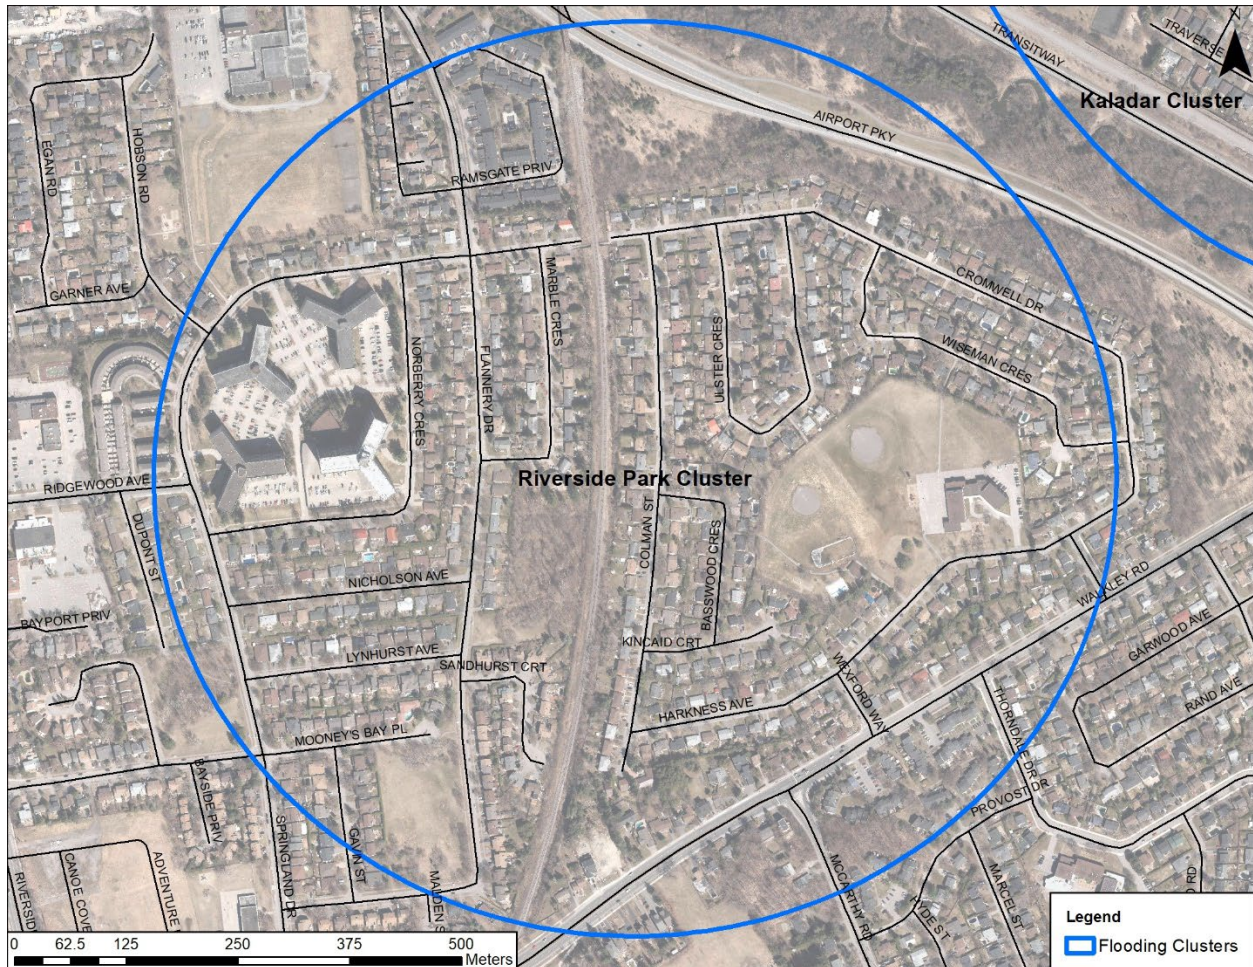
**Figure 7 – Riverside Park Cluster, August 10 Flooding**

- **Location and System Characteristics:** Eighteen (18) properties reported flooding in the August 10<sup>th</sup>, 2023 event. The Riverside Park area was developed in the mid-1960s and is fully separated, which means that weeping tiles are connected to the storm sewer system. This area is therefore more at risk of flooding due to storm sewer surcharge than from sanitary sewer surcharge.

- **Type of Flooding.** First response data does not provide any indication as to how the properties flooded. Resident flood questionnaires reported flooding of reverse driveways due to overland flow and flooding from the floor drain in at least one case. There were also reports of street flooding on Harkness, Lynhurst, Nicholson, Springland, Norberry and Ulster.
- **Previous Flooding:** There are approximately 30 reports of basement flooding in this area from previous years. Most of the flooding occurred during high intensity thunderstorm events, such as the ones in 1996, 2009 and 2011. The flooding reports were interspersed throughout the area for each event, which did not create specific clusters. A review of all flooding events, though, show that this area does in fact form a cluster due to flooding from storm sewer surcharge.

- **Probable Cause of Flooding:** Surcharged storm sewers led to basement flooding in this cluster area as well as excess overland flow in the rear yard system along Colman Street.

- **Next Steps:** The flooding situation in Riverside Park is complex in that the overland system is creating much of the problems. Excess flow from Pauline Vanier School and park is spilling into rear yards and flooding homes. The City will study this area in greater detail to see if storage in the park can be implemented to reduce the overland flow. Streets with low points are another issue. This area was designed and built in the early to mid-60s using the standard of the time. Overland drainage was not taken into consideration as it is today, and as such water accumulates in low points and spills through private properties. This is especially problematic if there are reverse slope driveways on the street. In many instances, a hump can be added to reduce spillage into the driveway, but that is often not enough protection for critical events. Communication with residents will be needed to explain the flooding risk so that they can find ways to further protect their properties. The City will also look at ways of reducing flow accumulation at low points if feasible. Note that any option that includes storage in parks or other locations, will most likely require an EA study, which will add one or two years to the study period.

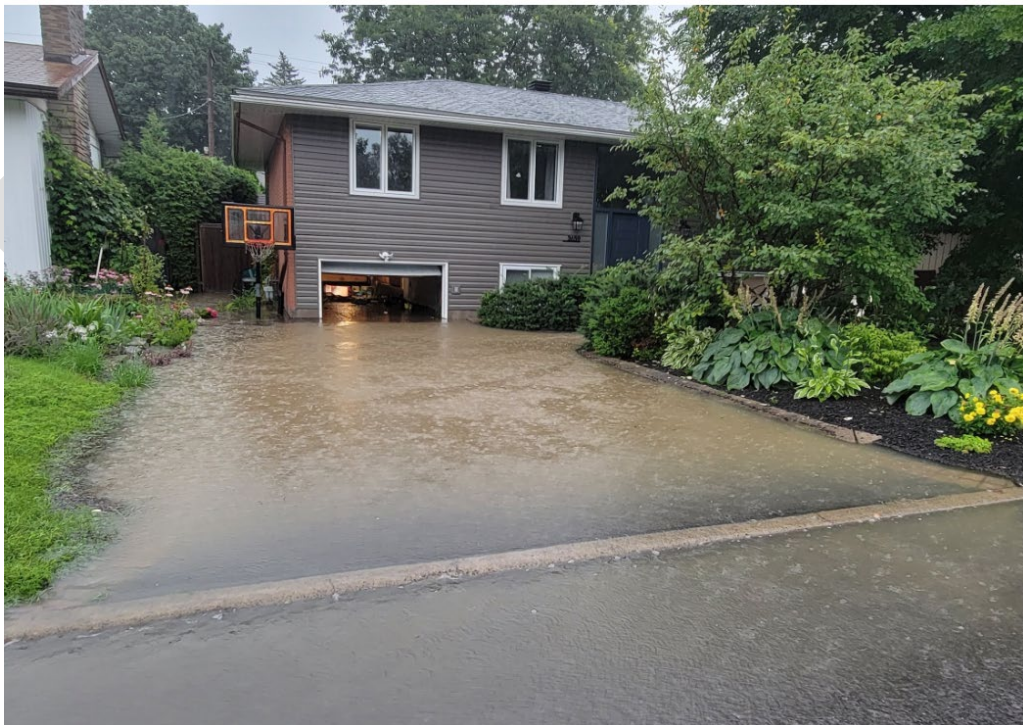
**Figure 8 – Flood on Colman Street**

In addition, there were numerous reports of overland flooding on various streets. An analysis of the overland drainage system shows a significant amount of overland flow coming from Pauline Vanier Park. This runoff would have flowed behind the homes along Colman Street flooding rear yards and a reverse driveway on Colman as water flowed from the rear yard to the street (see image below). The resident on Colman also noted water coming out of the basement plumbing. This would indicate that the sanitary system was most likely impacted due to flooded basements as water drains back to the sewer via the floor drains.

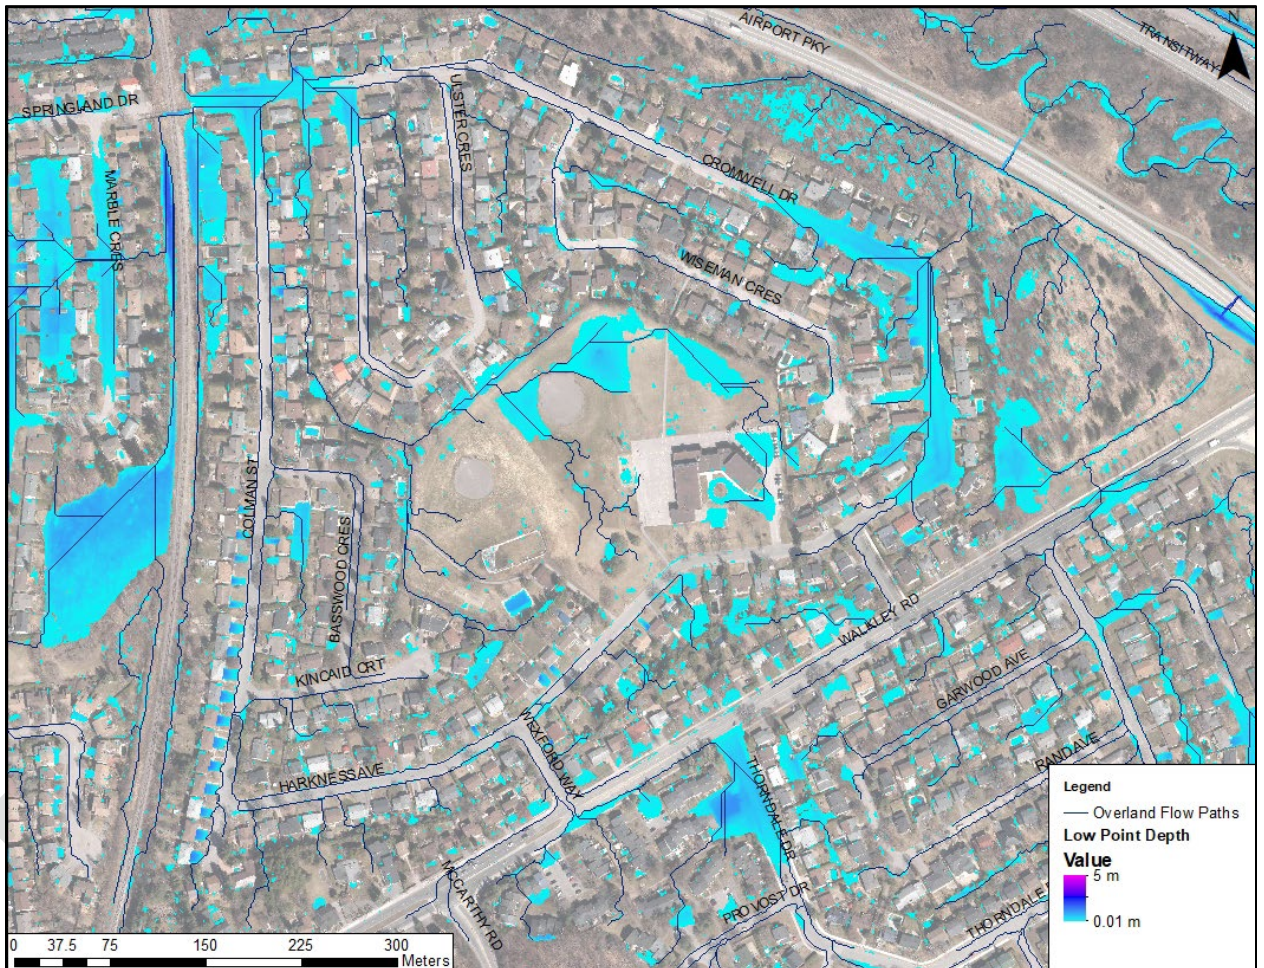
**Figure 9 – Riverside Park Cluster, Overland Flow Paths and Low Points**

The image below shows the overland flow paths and low points in this area, which clearly shows the flow from Pauline Vanier Park into the rear yards on Colman.

Streets that report flooding include Harkness, Lynhurst, Nicholson, Springland, Norberry and Ulster. In many of these instances, reverse slope driveways were impacted, and basements flooded as a result. Low points have been observed on Lynhurst, Nicholson, Springland and Norberry and unfortunately these low points were part of the original design and cannot be removed without re-grading the neighbourhood.

The storm sewer system will also be looked at in greater detail to see if the level of surcharge can be reduced by restricting catch basin inflow. This will be problematic though, because in new subdivisions this is done by restricting flow into the sewers and managing excess water on the streets. In our case, street drainage is already a major problem, and we would be exacerbating it by adding more surface drainage.
